# Manhole Inspection Summary

Manhole # S39A2\_011MH

Insp Date: **12/13/07 8:22 AM**

**Location** Address: **3904 Brooklyn Ave**

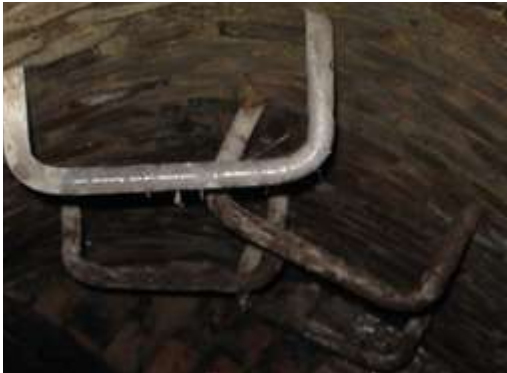
Count: **4** Missing: **0** ☒ **Corroded**

steps

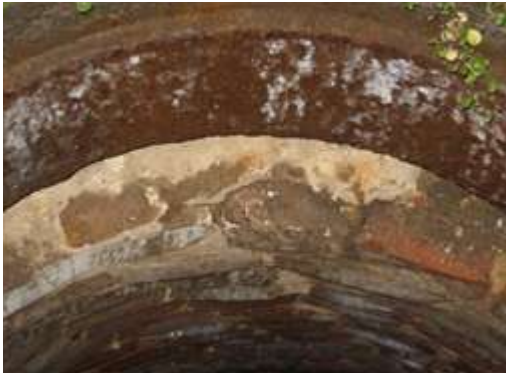
Defect 1

Offset: **3** (in.)

Condition: ☐ Sound ☐ Cracked ☐ Root Intrusion ☒ **Loose Brick** ☐ Deteriorated

frame offset  
loose bricks on chimney

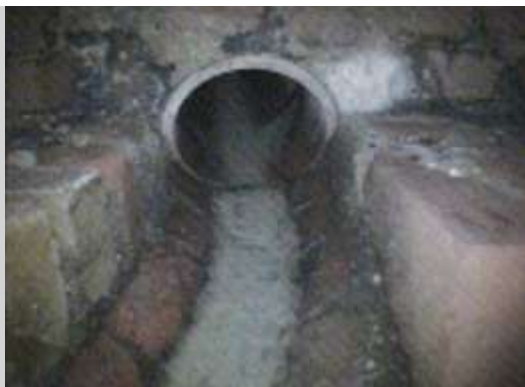
3 O'Clock Inflow

Pipe Height: **7.2** (in.) Rod and Bar (Angled)  
Pipe Material: **Clay** ☐ Pipe Lined  
Invert Depth: **8.28** (ft.) Flow Characteristics: **Slow**  
Deposits: ☒ None ☐ Mud ☐ Sludge ☐ Debris ☐ Grease  
Silt Depth: (in.) Deposits Extent:  
Infiltration: **None** Pipe Seal Cond: **Sound**

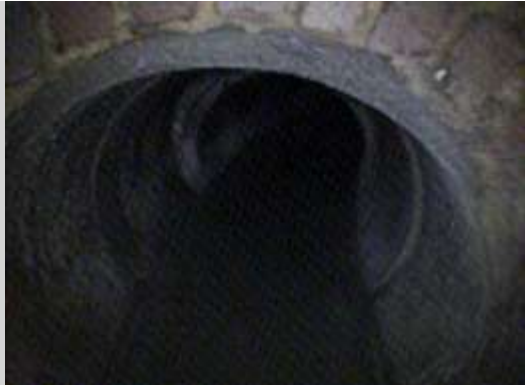
6 O'Clock Inflow

Pipe Height: **21.6** (in.) Rod and Bar (Angled)

Infiltration: **None** Pipe Seal Cond: **Sound**

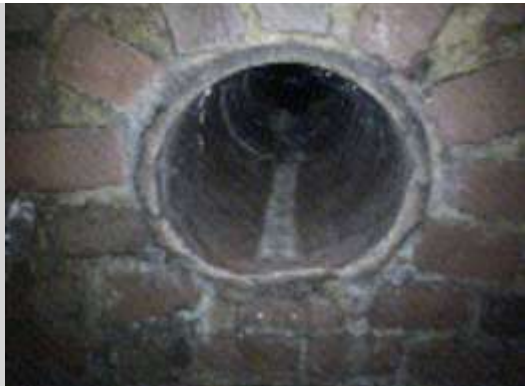
10 O'Clock Inflow

Pipe Height: **8.4** (in.) Rod and Bar (Angled)

Infiltration: **None** Pipe Seal Cond: **Sound**

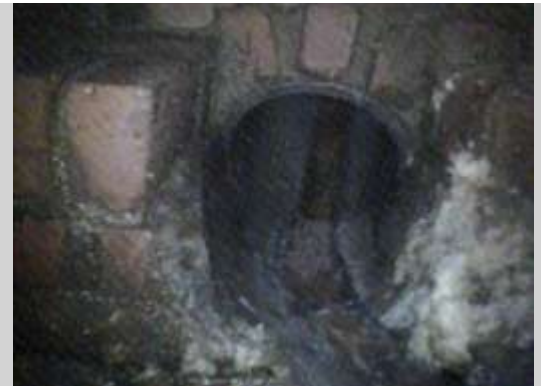
Drop In @ 9 O'Clock

Drop: **Outside** Rod and Bar  
Angled: **Yes** Reading: **8.05** (ft.)  
Inv Depth: **9.05** (ft.)

Drop Condition: **Open**
